# Manhole Inspection Summary

Manhole # S15GG1010MH

Insp Date: **12/13/06 2:57 PM**

**Location** Address: **2556 QUANTICO AVE**

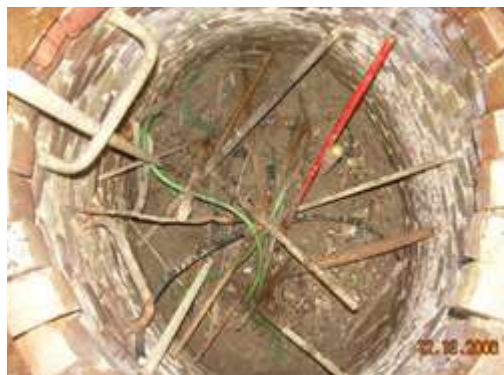
Top View

Corroded steps. Channel debris.

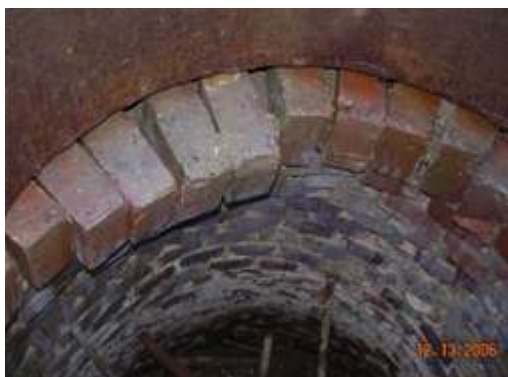
Defect

Frame leaks. Frame offset. Adjustment deterioration, loose brick and infiltration. Barrel infiltration.

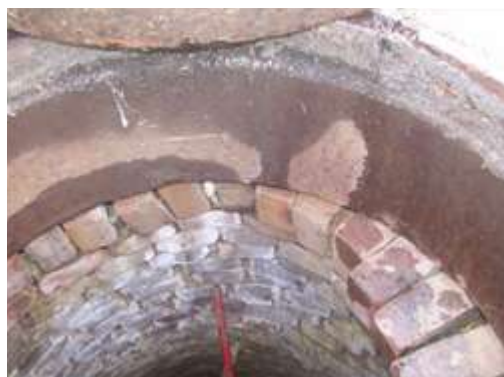
Defect

Frame leaks. Frame offset. Adjustment deterioration, loose brick and infiltration. Barrel infiltration.

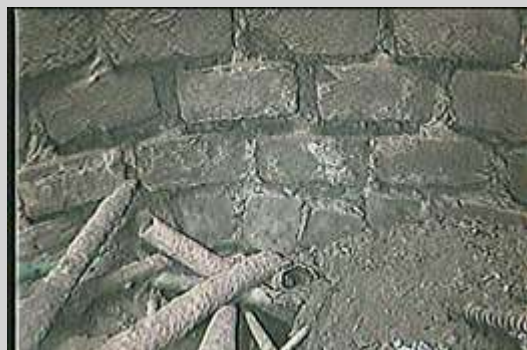
Pipe Out @ 12 O'Clock

Deposits: ☐ None ☒ **Mud** ☐ Sludge ☒ **Debris** ☐ Grease

Silt Depth: **8** (in.)

Deposits Extent: **Heavy**

Infiltration: **Evidence**
